# Restoration Plan for the Clark Fork River and Blackfoot River near Milltown Dam – October 2005

Westwater Consultants, Inc.  
1112 Catherine Lane  
Corvallis, MT 59828

River Design Group, Inc.  
5098 Highway 93 South  
Whitefish, Montana 59937

Geum Environmental Consulting, Inc.  
301 South 3rd Street, Suite 103  
Hamilton, MT 59840

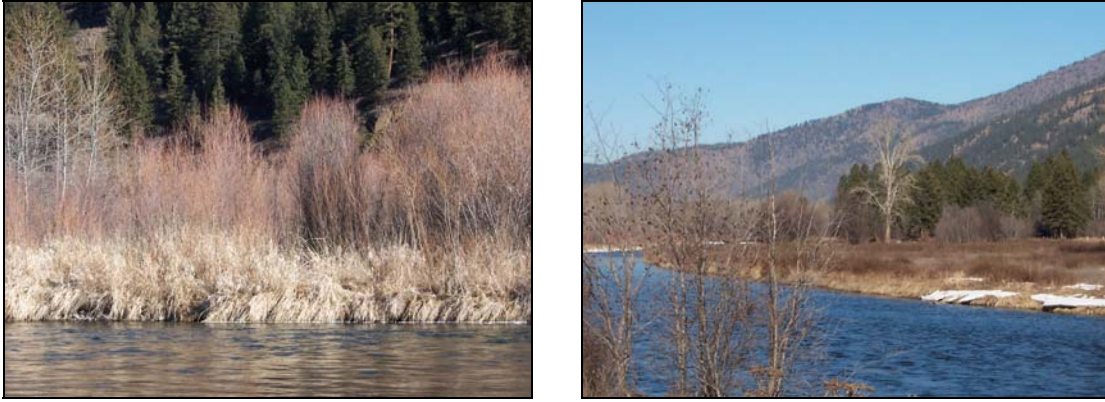
**Figure 2-1.** Existing vegetation conditions on the CFR floodplain in the vicinity of the Turah Bridge. Reed canarygrass dominates stream banks (left). Other invasive weed species including common tansy and spotted knapweed are other frequent noxious weeds (right).

One of the most striking observations made while evaluating existing conditions on the floodplain was the significant weed infestations along streambanks and on floodplains. In the vicinity of Turah Bridge, reed canarygrass (*Phalaris arundinacea*) dominates the herbaceous layer under a stand of sandbar willow (Figure 2-1). Common tansy (*Tanacetum vulgare*) dominates a point bar, spotted knapweed (*Centaurea maculosa*) occupies slightly higher microsites, and canarygrass has colonized the immediate streambank. Because weeds are so significant, our revegetation strategies (Section 3) include several methods to limit weed infestation in restoration areas.
